MAJOR ORIENTATION-ERROR ACCIDENTS IN REGULAR ARMY UH-1

AIRCRAFT DURING FISCAL YEAR 1967: ACCIDENT FACTORS

W. Carroll Hixson, Jorma I. Niven, and Emil Spezia

October 1970

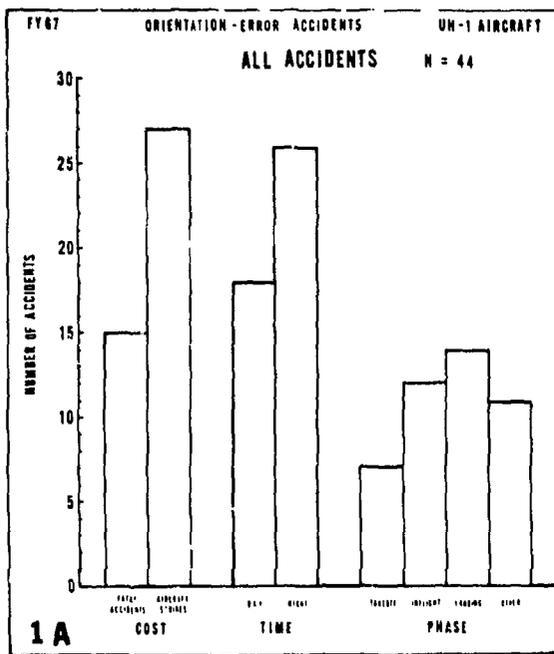
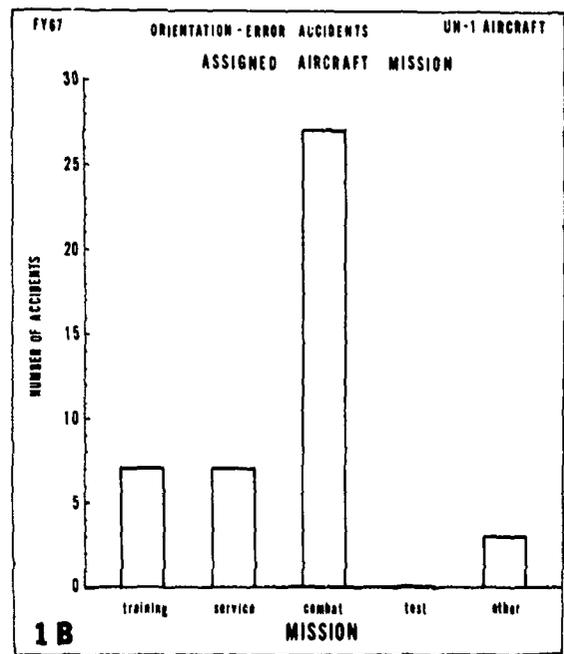
Figure 1

Major orientation-error accidents occurring in Regular Army UH-1 aircraft during fiscal year 1967. Number of fatal accidents, number of aircraft strikes, time of day of the accidents, and the flight phase in which the accident occurred (A); and types of missions assigned to the accident aircraft (B).

Before presenting the individual case-history data for these 44 accidents, a brief summary will be made of selected background information pertinent to the accidents as a whole. As indicated by the cost data in Figure 1A, the hazard of orientation-error accidents was considerable for that fiscal year. Some 34.1 percent of the accidents were fatal, while 61.4 resulted in a total loss of the aircraft. The time-of-day data show that the majority of the accidents (59.1 percent) occurred at night. In terms of the phase of flight in which the accident occurred, Figure 1A indicates that the greatest number of accidents took place while landing, the least during takeoff. It should be noted that the "other" phase classification used in this report denotes localized operations, such as reparking an aircraft, lifting a sling load, or moving an aircraft to a nearby refueling site. Though such operations may involve a takeoff, a short hovering flight, and a landing within the confines of a field, the takeoff classification is reserved solely for conventional outbounds or departures, the landing classification for inbounds, and the inflight classification for the intermediate phase.

The mission data presented in Figure 1B show that the majority (61.4 percent) of the accidents occurred on flights that had some form of combat-related mission assignment. This would be expected since 37 (84.1 percent) of the 44 accidents occurred in Vietnam. The reader is reminded that although a combat mission may have been assigned to the crew, the resulting mishap was an accident and not a loss attributable to direct enemy action.

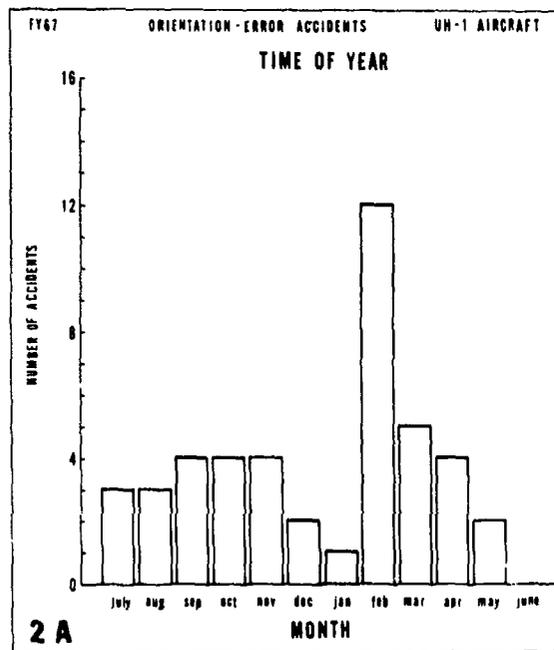
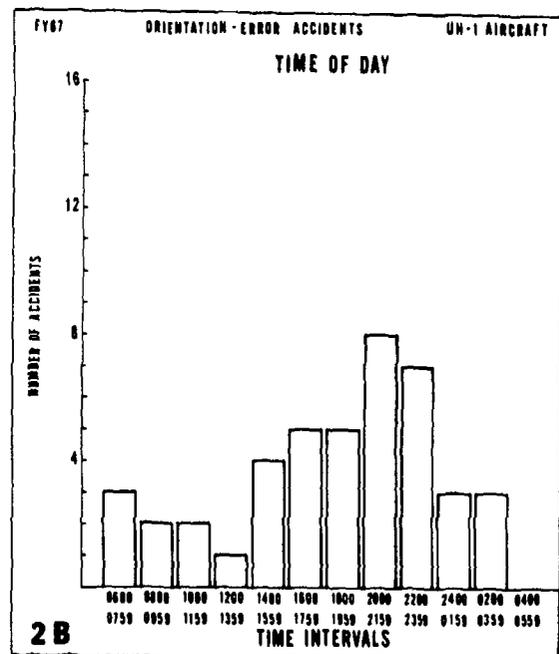
Figure 2

Number of orientation-error accidents as a function of the time of year (A) and the local time of day (B).

In Figure 2A a distribution is given of the number of accidents during each month of the fiscal year. Since the majority of the accidents occurred in Vietnam, the time-of-year incidence of accidents due to weather and dust peaked in that country's monsoon and dry seasons, respectively. Interpretation of these data beyond this point is restricted by

the month-to-month variations in the level of combat operations being conducted at a given time. Similarly, the daily variation in frequency of operations would affect interpretation of the hourly distribution data plotted in Figure 2B which shows accident incidence in 2-hour increments over a 24-hour period.

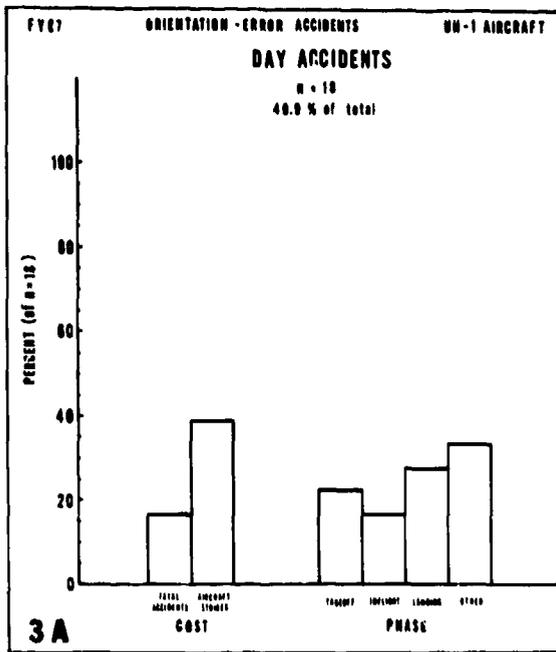
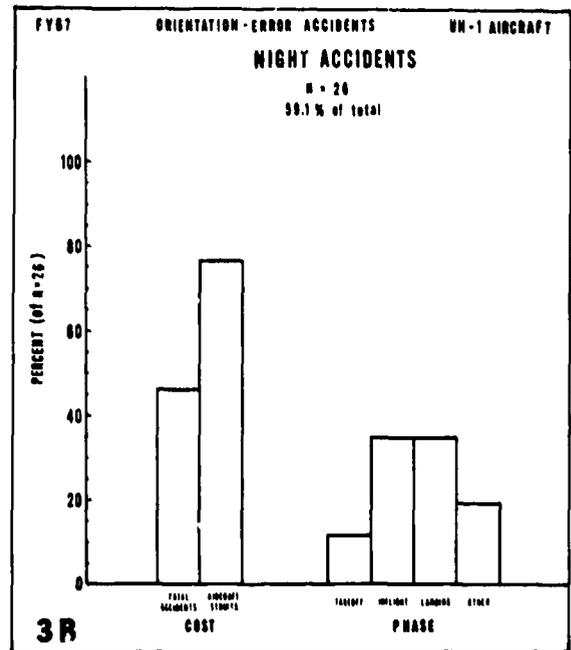
Figure 3

Comparison of percent incidence of fatal accidents, aircraft strikes, and flight phases for the 18 orientation-error accidents that occurred under daylight visibility conditions (A) and the 26 accidents that occurred under night visibility conditions (B). Note the considerably greater hazard of the night flights.

Additional data related to the time-of-day incidence of the accidents are presented in Figure 3. Statistics pertinent to the 18 accidents that occurred under daylight visibility conditions are plotted in Figure 3A. Similar data for the 26 night accidents are shown in Figure 3B. It is obvious that the cost of night accidents in terms of fatal accidents and aircraft strikes was considerably greater than the corresponding costs of daylight accidents. That is, 46.1 percent of the night accidents were fatal compared to only 16.7 percent of the daylight accidents; 76.9 percent of the night accidents resulted in aircraft strikes as compared to only 38.9 percent of the daylight accidents. In terms of the phase of flight for the night accidents, the inflight and landing phases had equal incidence, followed by the "other" and takeoff phases in that order. For the daylight accidents, the greatest incidence occurred in the "other" phase followed by the landing, takeoff, and inflight phases.

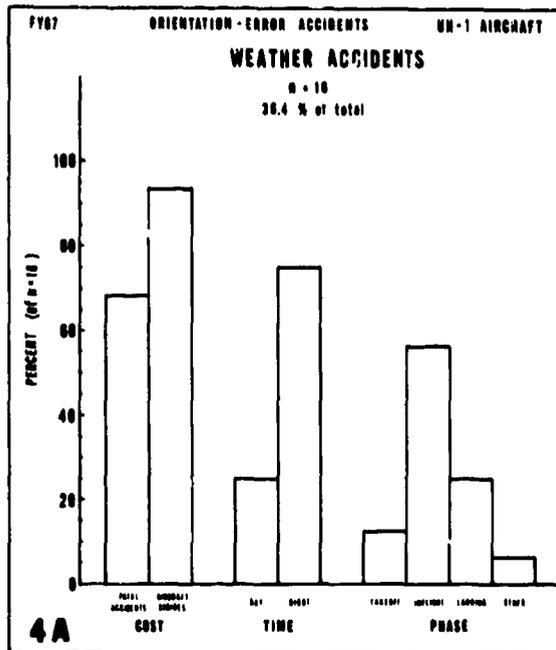
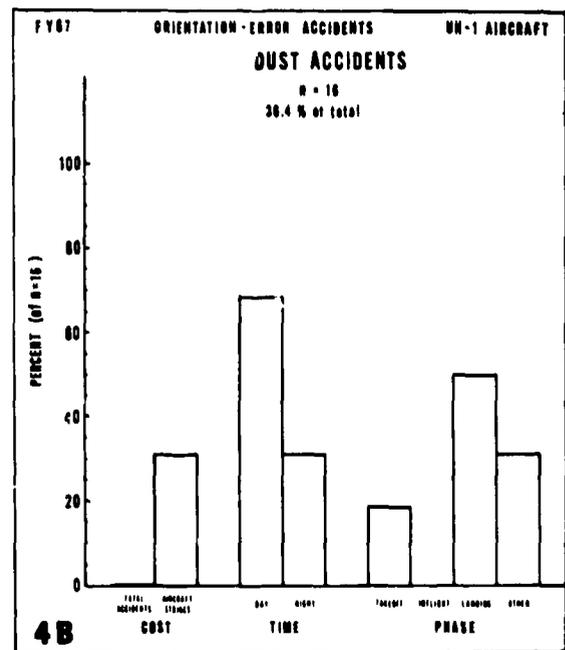
Figure 4

Comparison of percent incidence of fatal accidents, aircraft strikes, day/night accidents, and phases of flight for the 16 orientation-error accidents that involved poor weather (A), and the 16 accidents that involved rotor-raised ground dust or ashes (B). Note the high incidence of fatal accidents and aircraft strikes involved in the weather accidents.

Data pertaining to accidents involving degraded visibility due to weather and rotor-raised ground dust are presented in Figure 4. As denoted in Figure 4A, poor weather of one form or another was present in 16 (36.4 percent) of the 44 major orientation-error accidents. The hazard of these weather accidents was most significant since 68.7 percent of the accidents were fatal and 93.7 percent resulted in aircraft strikes. The majority (75 percent) of these accidents occurred at night. In terms of the phase of flight when the accident occurred, the inflight phase had the highest incidence (56.25 percent). When these weather accidents involved flight at night, the incidence of fatal accidents rose to 75 percent. Of the four daylight accidents, two were fatal.

As indicated in Figure 4B, degraded visibility due to rotor-raised ground dust or ashes was present in an additional 16 accidents. Though no fatalities resulted from these dust accidents, a considerable number (31.2 percent) involved the total loss or strike of the aircraft. Relative to the phase of flight, landing accidents had the greatest incidence (50.0 percent); as will be gained from reading the individual case history briefs which follow, these occurred at established heliports as well as at temporary field sites. It appears from a cursory scan of the orientation-error accidents occurring in subsequent fiscal years of this study that application of penepreme or similar surface coverings to minimize dust has decreased the incidence of this form of accident.

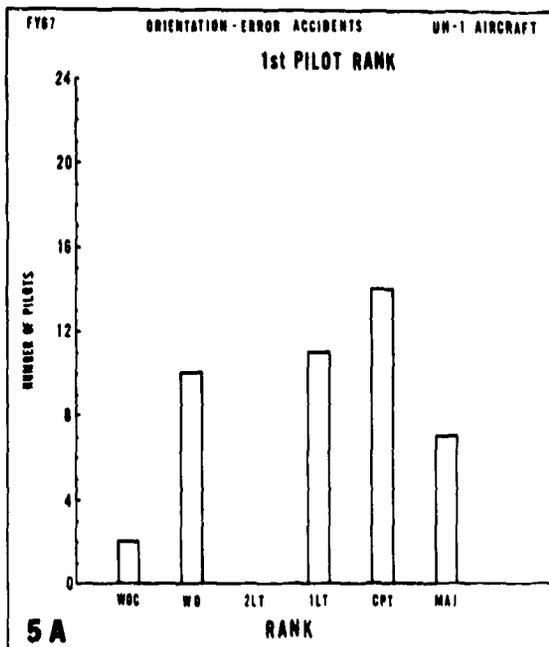
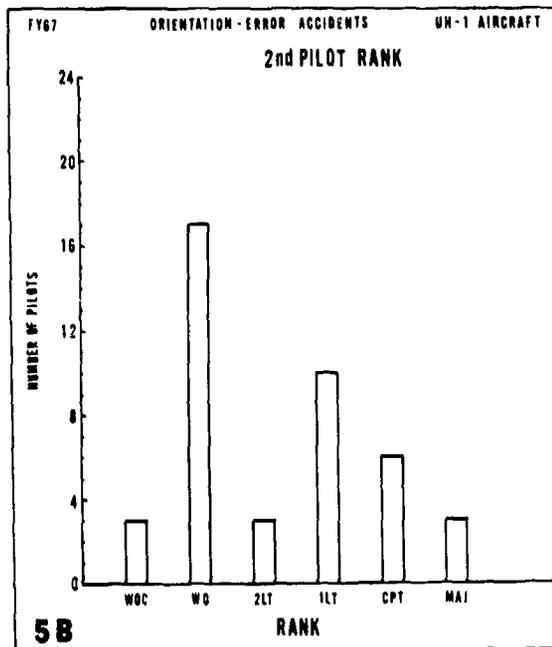
Figure 5

Distribution by rank of the 44 first pilots (A) and the 42 second pilots (B) involved in the orientation-error accidents. As explained in the text, the first pilot notation is used to describe the commanding aviator aboard the aircraft. In general, for Vietnam accidents, the first pilot is the "air commander" and the second pilot is the "pilot." For accidents occurring elsewhere, the first and second pilot notation usually corresponds to the conventional "pilot" and "copilot" designations, respectively.

Data pertaining to the rank of the first and second pilots involved in the 44 orientation-error accidents are shown in Figures 5A and 5B, respectively. In the case of the 44 first pilots, there were almost as many individuals (21) with the rank of captain and above as there were of lower rank. As would be expected for the 42 second pilots (two accidents involved flights without a second pilot aboard) the median rank was lower, with 22 individuals having a rank of second lieutenant or above. The age distribution data, based on those whose ages were recorded, presented in Figure 6A for the 38 first pilots indicate a median of 27.8 years; Figure 6B data indicate a median of 24.9 years for 35 second pilots.

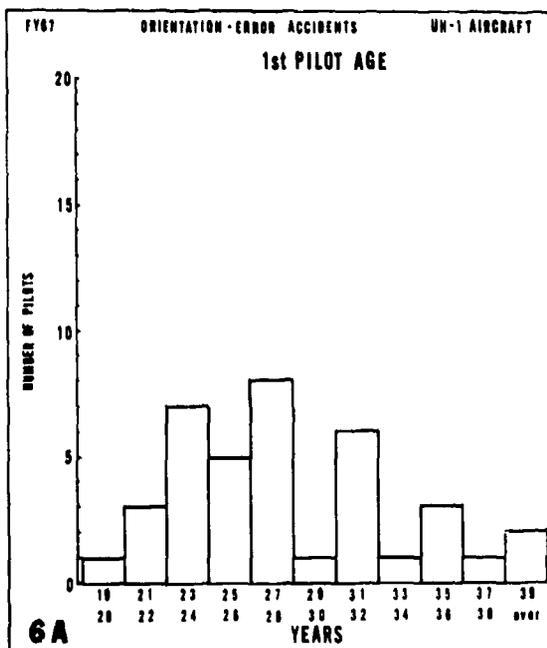
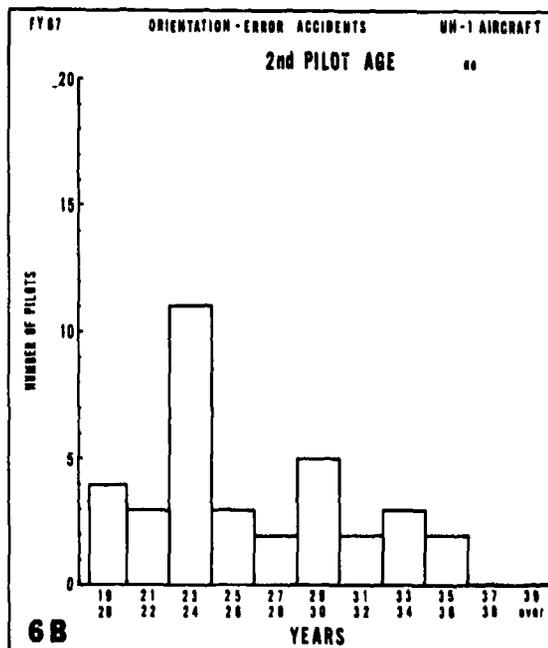
Figure 6

Age distribution of the first pilots (A) and second pilots (B). The median ages were approximately 27.8 years and 24.9 years, respectively.

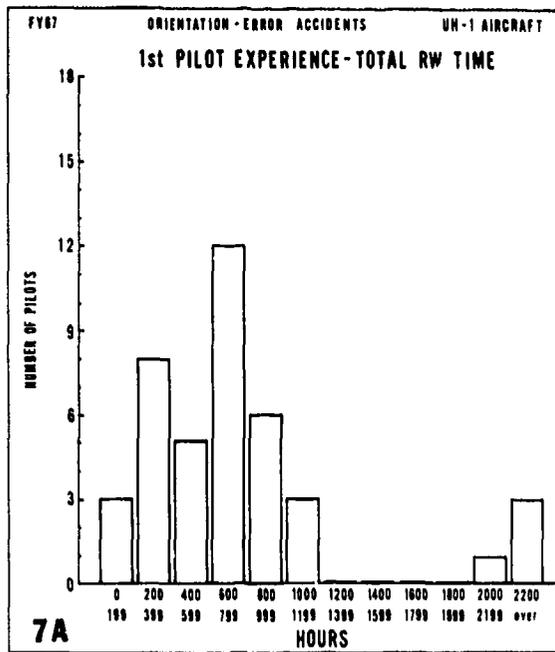
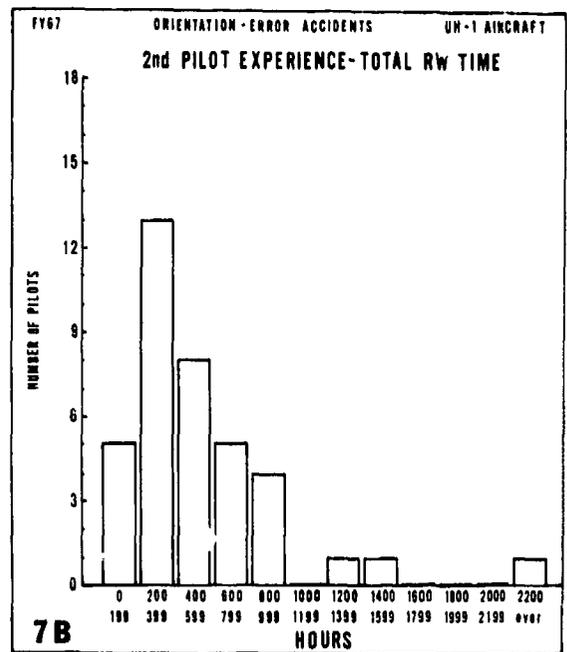
Figure 7

Distribution of total flight hours experience in military rotary-wing aircraft of the first pilots (A) and second pilots (B). The medians were approximately 675 hours and 425 hours, respectively. These data do not include any additional fixed-wing experience. (See Figure 10 for related FW and RW experience data.)

Aviator experience in terms of total flight hours both in all types of rotary-wing aircraft and in the UH-1 aircraft is described by Figures 7 and 8, respectively. The median

for the total recorded RW experience data, presented in Figure 7, was 675 hours for 41 first pilots and approximately 425 hours for 38 second pilots. The median times for total UH-1 experience were approximately 350 hours and 147.7 hours for the 42 first and 37 second pilots, respectively.

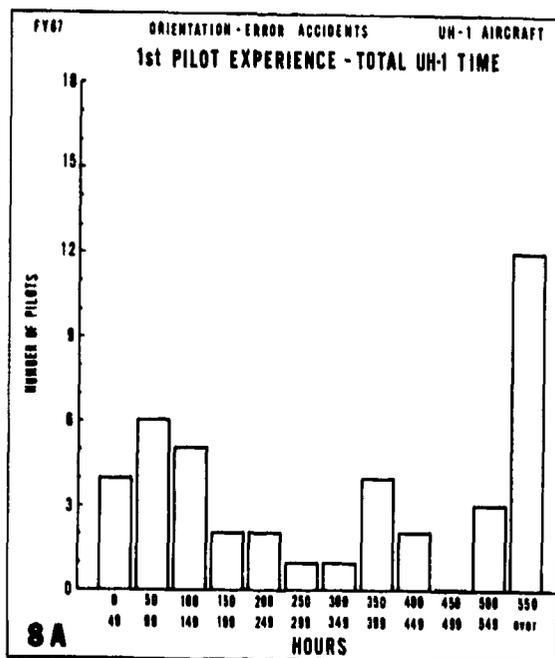
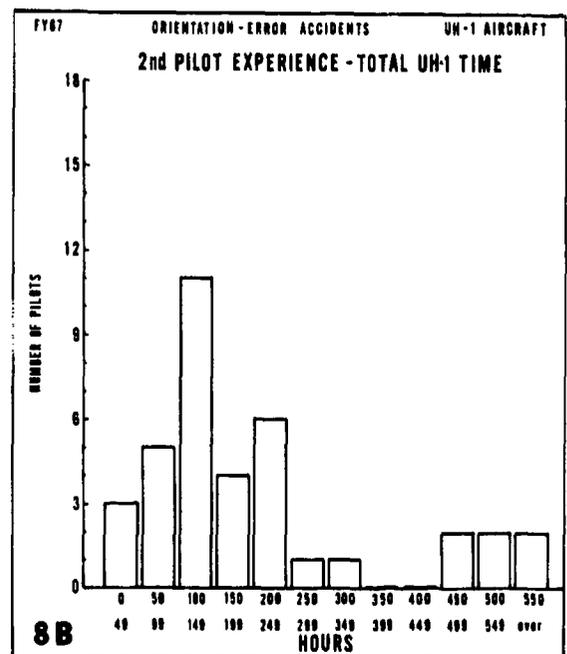
Figure 8

Distribution of total flight hours in the UH-1 aircraft of the first pilots (A) and second pilots (B). The median times were approximately 350 hours and 147.7 hours, respectively. (See Figure 10 for related UH-1 experience data.)

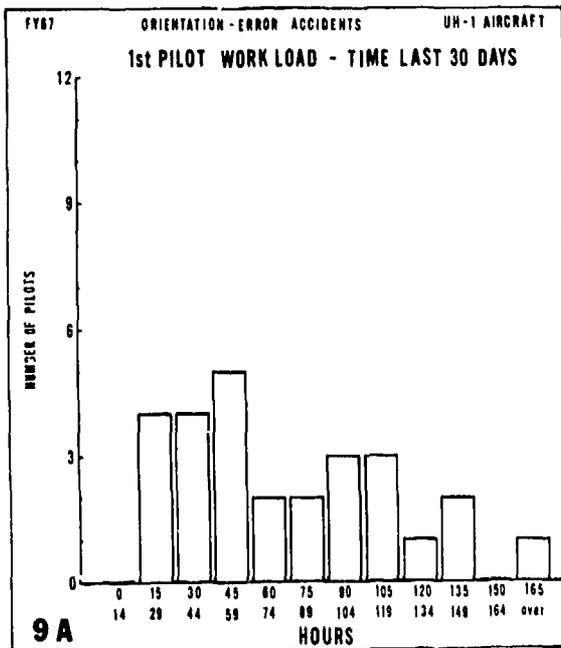
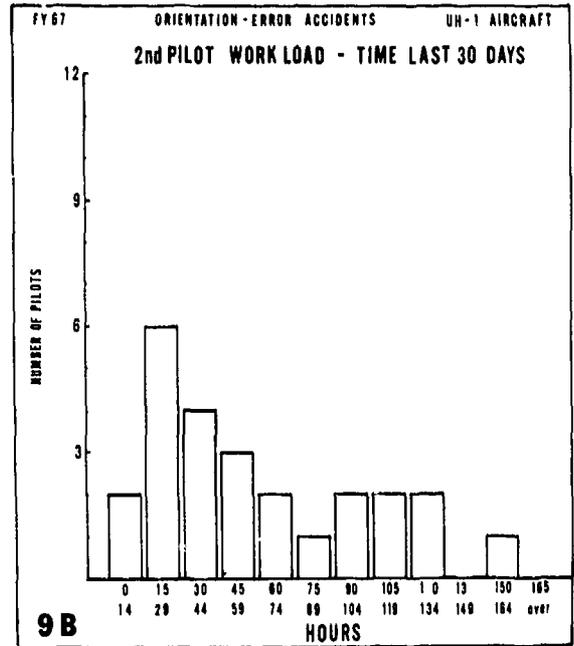
Figure 9

Distribution of pilot workload in terms of the total number of hours flown the 30 days preceding the accident by the first pilot (A) and the second pilot (B). The median workloads were 63.7 hours and 57.5 hours, respectively. (See Figure 11 for related fatigue listings.)

Work-load data concerned with the total number of hours flown by the aviators the 30 days preceding the accident are shown in Figure 9; specific hours data were available for only 27 of the first pilots and 25 of the second pilots. The median times were approximately 63.7 hours for the first pilots and 57.5 hours for the second pilots. Army regulations place 140 hours per 30-day interval as the official upper limit relative to pilot fatigue. After 90 hours, however, observation of the pilot by the air unit commander and flight surgeon is required.
